PLUTONIUM RELEASE INCIDENT

OF NOVEMBER 20, 1959

L. J. King
W. T. McCarley

A nonnuclear explosion involving an evaporator occurred in a shielded cell in the Radiochemical Processing Pilot Plant at Oak Ridge National Laboratory on Nov. 20, 1959. Plutonium was released from the processing cell, probably as an aerosol of fine particles of plutonium oxide, via three principal routes:

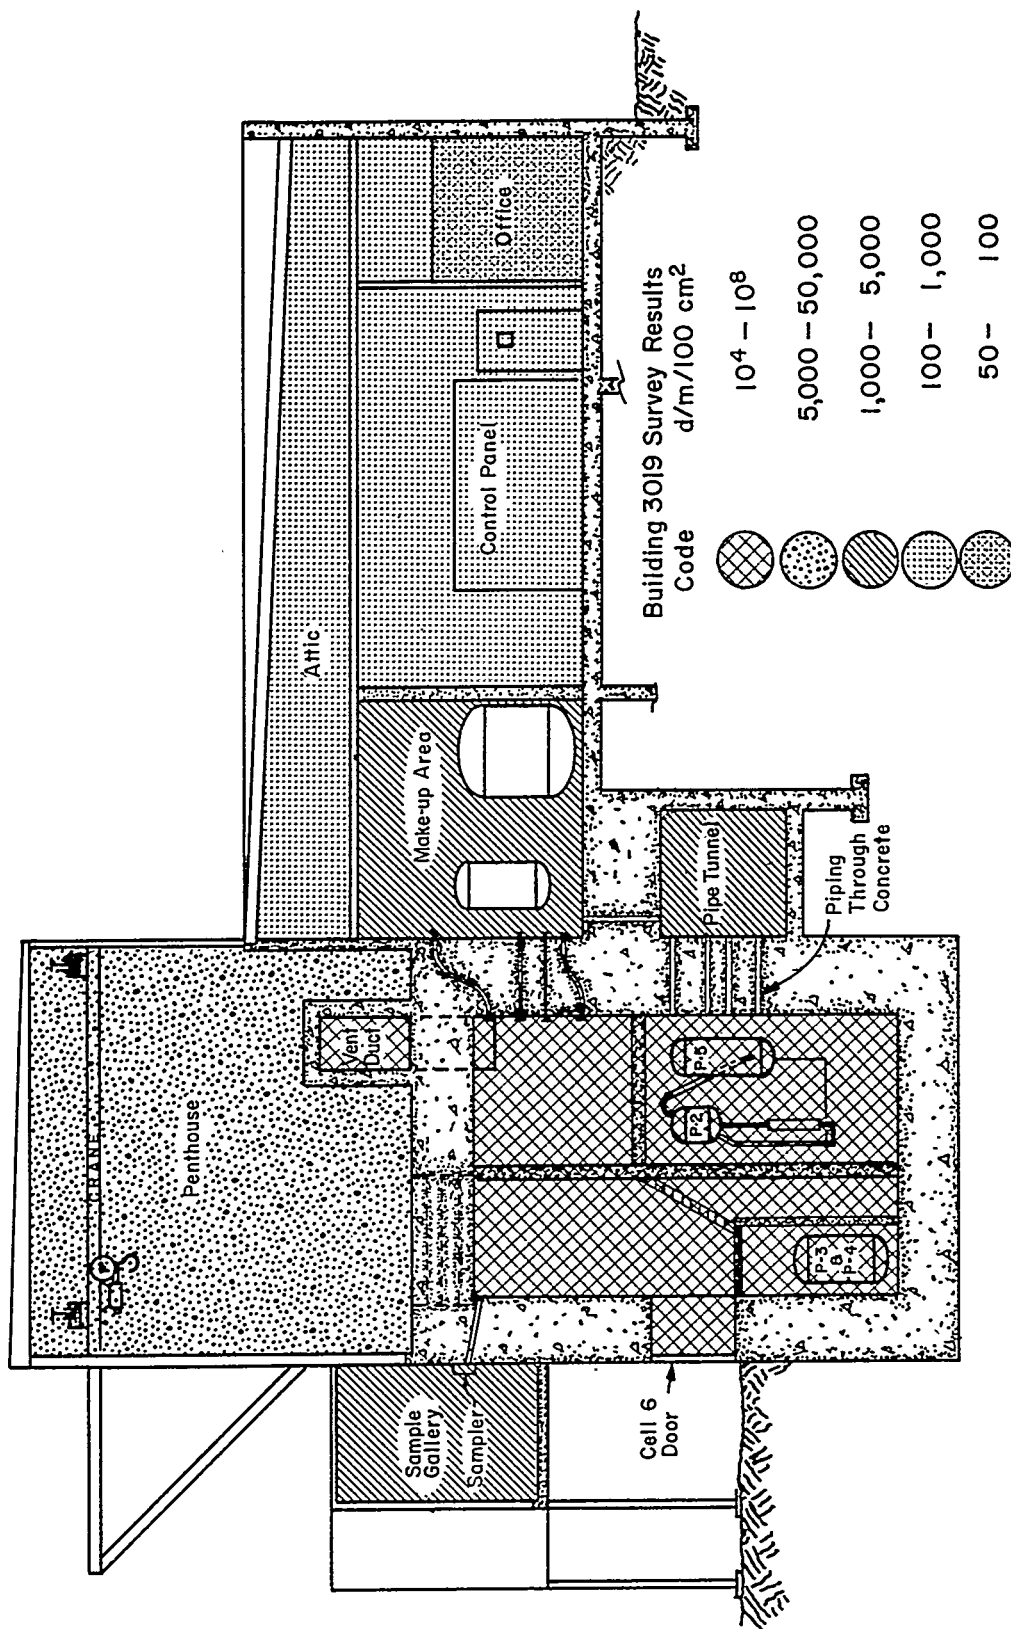
Fig. 3.4. Sectional elevation through cell 6, Radiochemical Processing Pilot Plant, showing inside contamination levels after explosion.

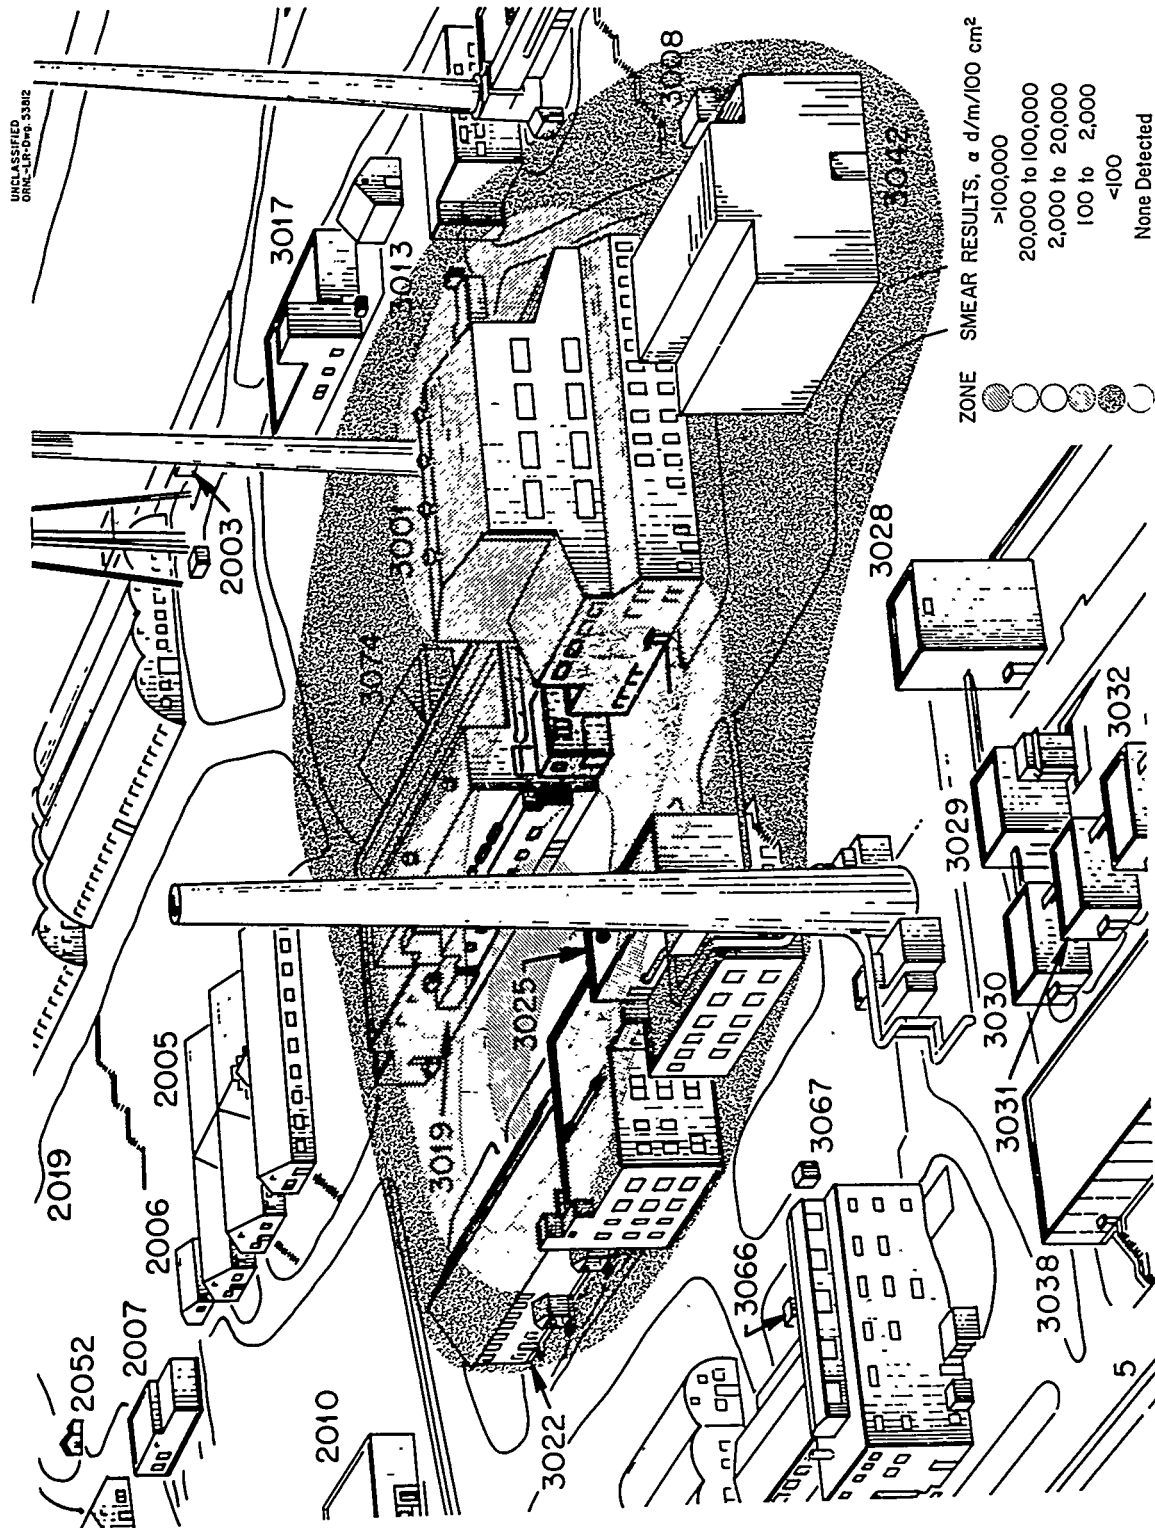
Fig. 3.6. Plutonium fallout zones after explosion.

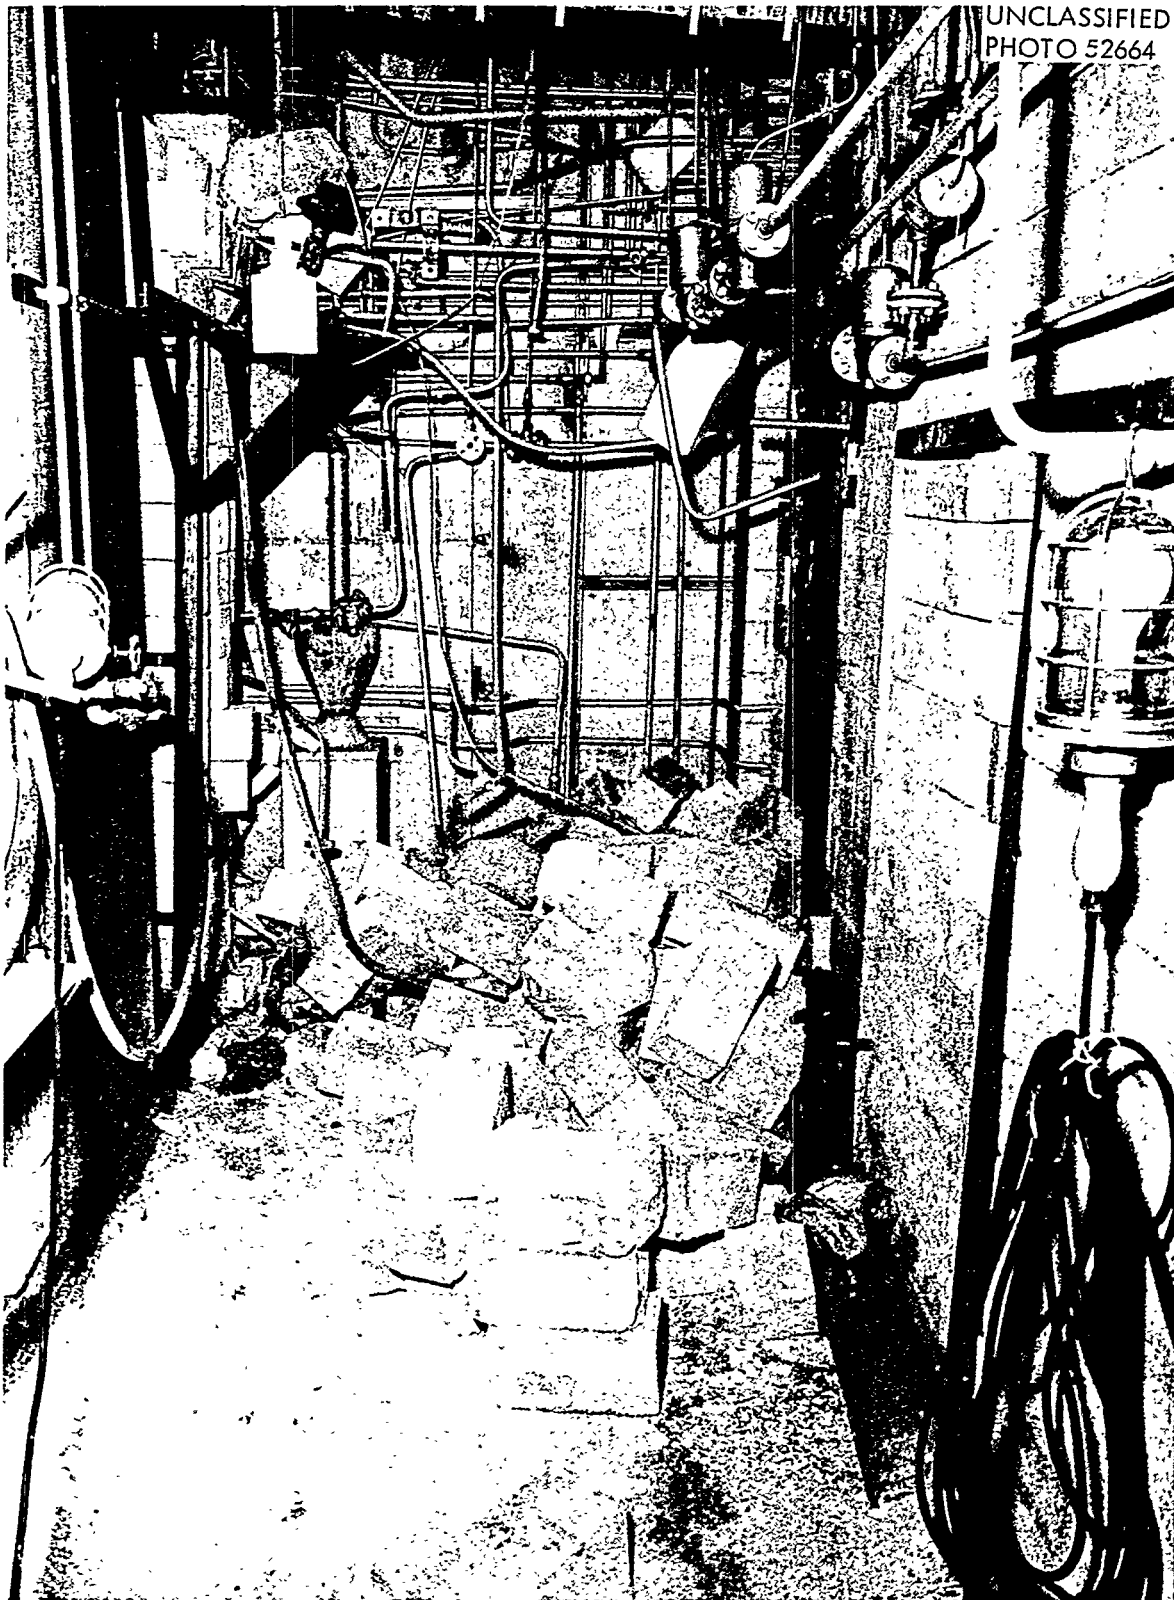
The shielding walls knocked down as a result of the explosion were constructed of barytes concrete blocks, which were dry-stacked. Very little force was required to bring about their collapse. Some of the blocks were

Fig. 3.8. Debris in front of evaporator subcell after explosion.

chipped slightly but, in general, individual blocks received little physical damage.

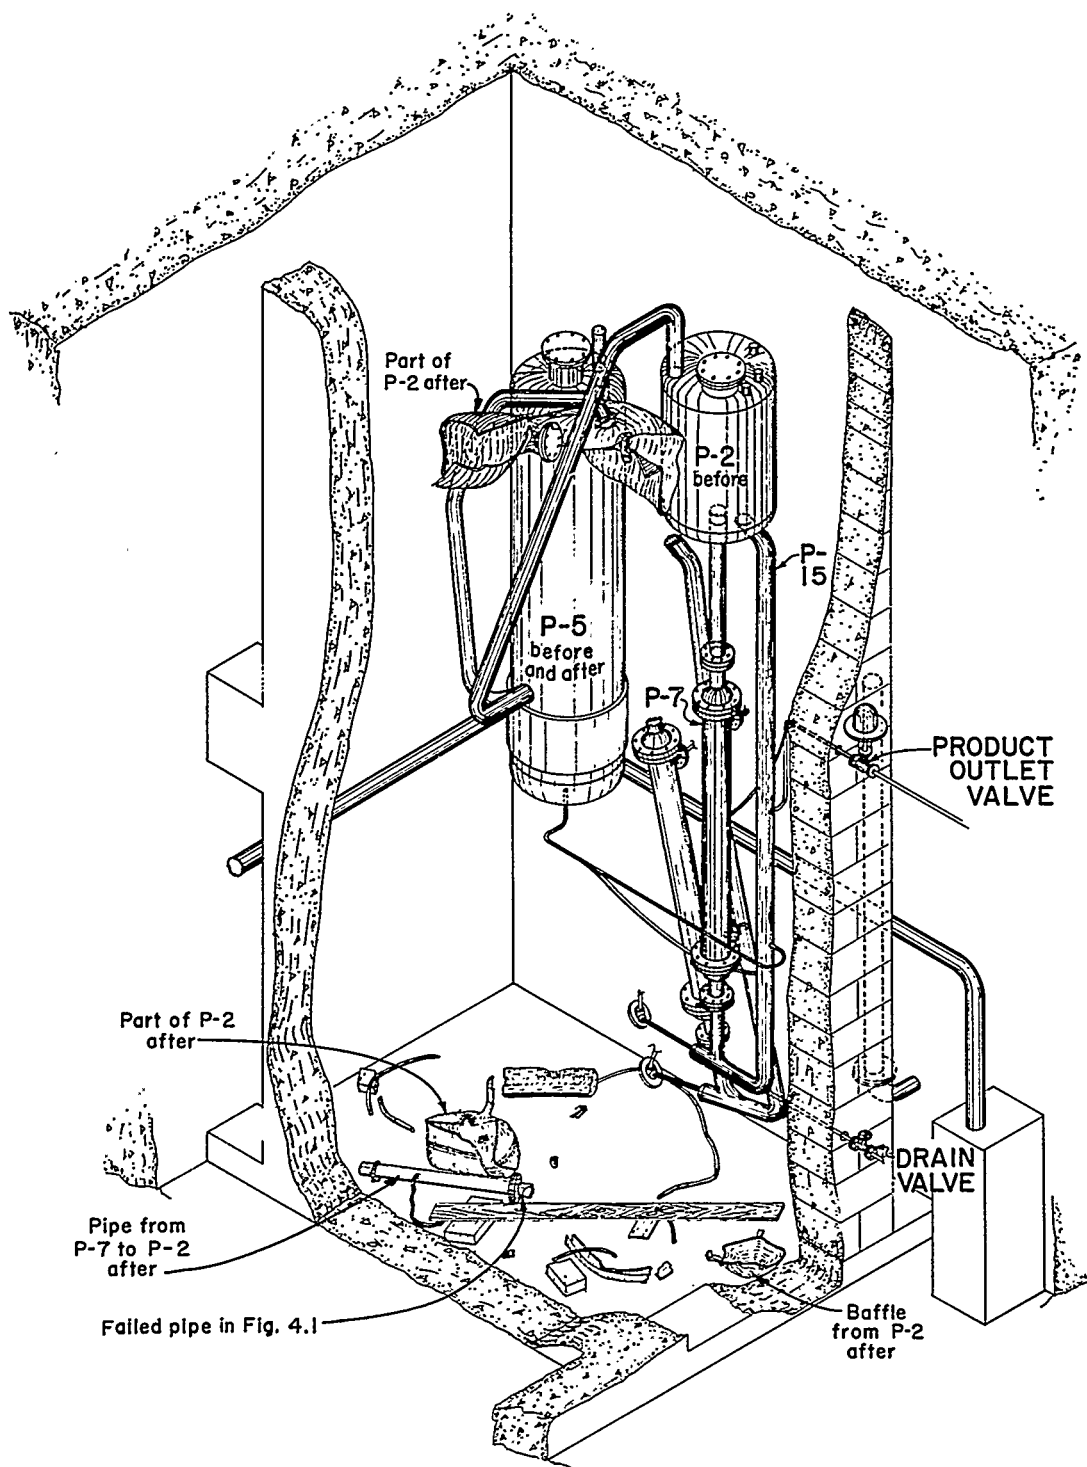
The explosion was a minor chemical explosion and physical damage was confined to the equipment in the evaporator subcell, a few pipes which were connected to this equipment, and the unmortared concrete block shielding walls which were in front of the subcell (Fig. 3.8) and in front of the cell 6 door. Access to the cell area has been limited, and it has not been possible to make a thorough examination of the ruptured evaporator. However, photographs of the subcell plus a few observations of the equipment have made possible a reasonably accurate description of the damage (Fig. 3.9).

Fig. 3.9. Intercycle evaporator before and after explosion.

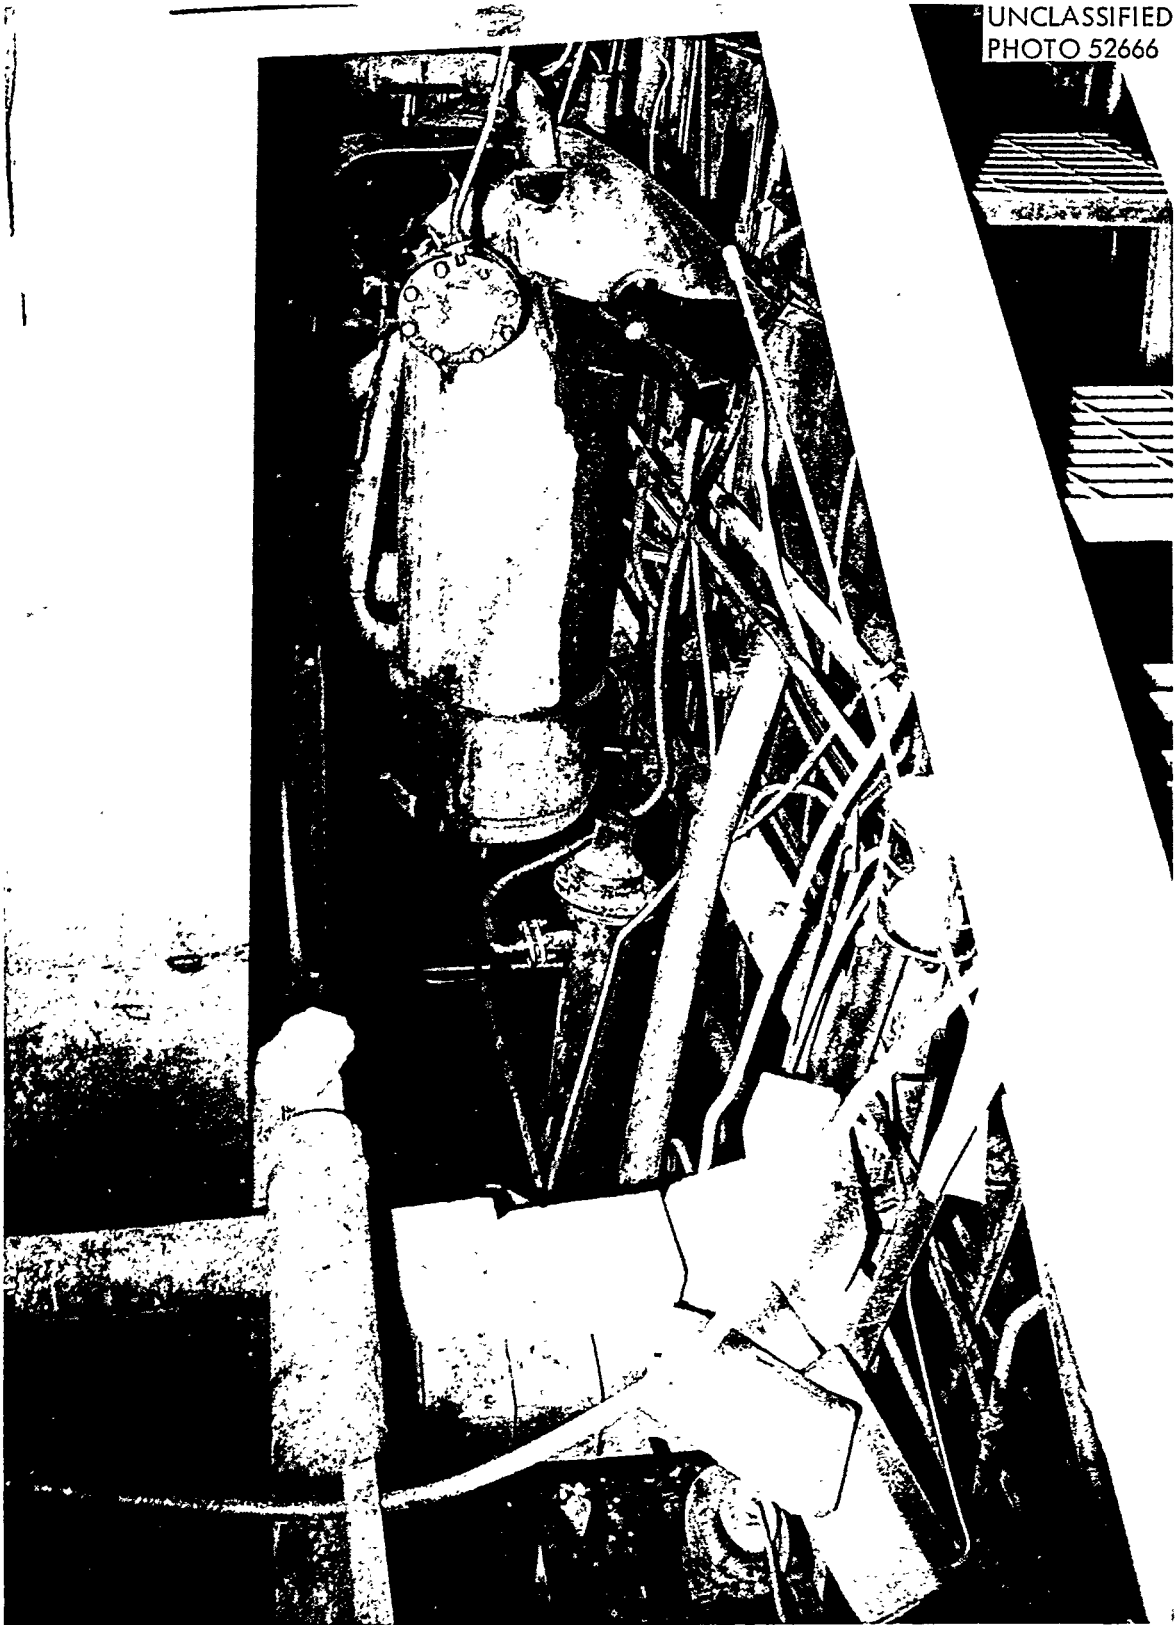
The vapor separator was torn apart by the incident. A large, badly deformed section that originally was part of the side and top and bottom was found lying on the floor in the subcell (Fig. 3.10). The remainder of the separator was found wrapped around the steam stripper which was dented by the impact (Fig. 3.11).

Fig. 3.11. Upper portion of evaporator subcell after explosion.

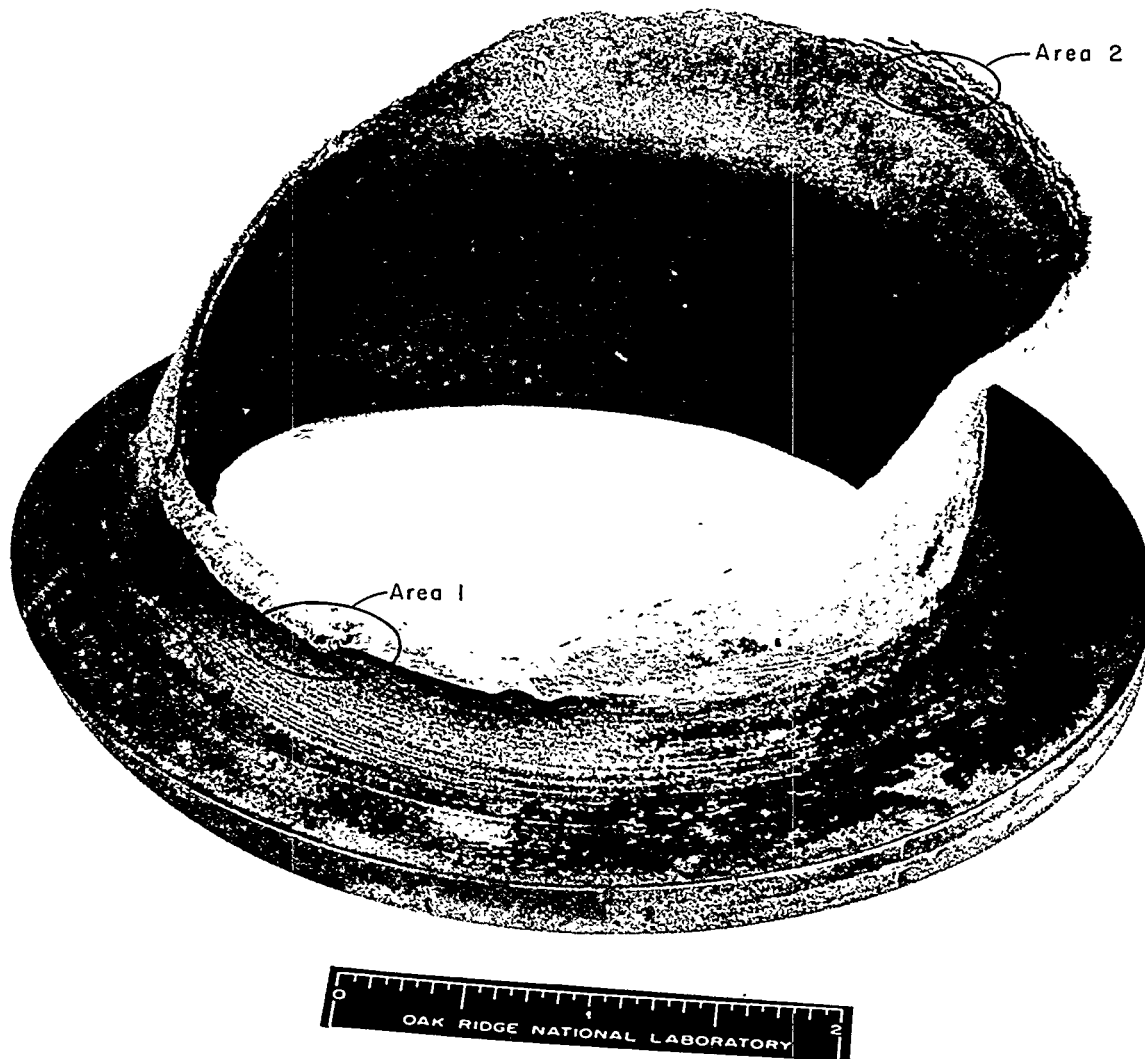
Fig. 4.1. Failed pipe from ruptured evaporator.

On the basis of these observations, it can be concluded that plastic deformation at the one side of the pipe preceded failure. Furthermore, it appears that once failure occurred in this area, the crack that resulted propagated rapidly through the remaining material without further plastic deformation.

5. There was no shock wave in the warm leg of the convection loop. Metallographic examination of specimens cut from the failed pipe (Fig. 4.1) which connected the convection loop heat exchanger to the vapor separator indicates that plastic deformation on one side of the pipe preceded failure.

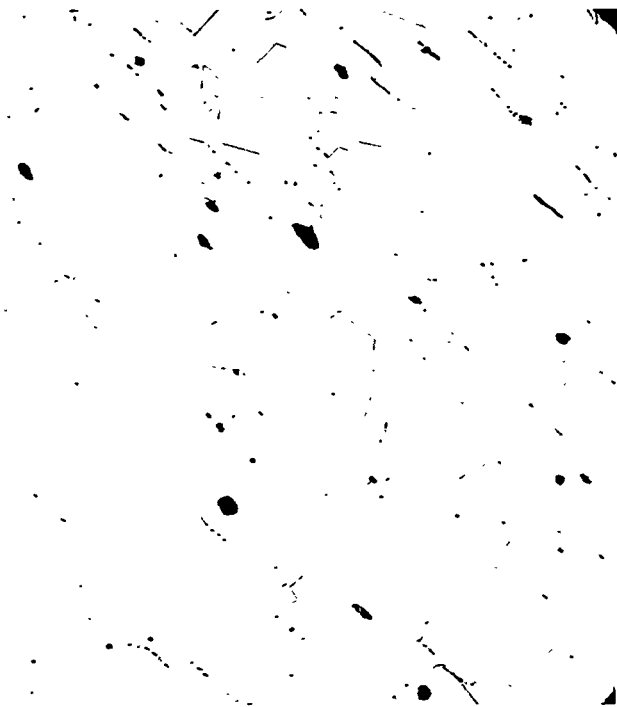
The normal structure of the pipe away from the areas of fracture is shown in Fig. 4.2a. The structure is equiaxed, with annealing twins being seen in some of the grains and can be considered typical of stainless steel. The wavy striated background structure, which appears in this photomicrograph faintly and is seen to varying degree in the remaining photomicrographs, is parallel to the direction of working. Coring-type segregation occurs during casting of the stainless steel, which produces variations in composition on a microscale. These regions of segregation are elongated during fabrication and are shown as a result of staining during etching.

Fig. 4.2a. Normal structure

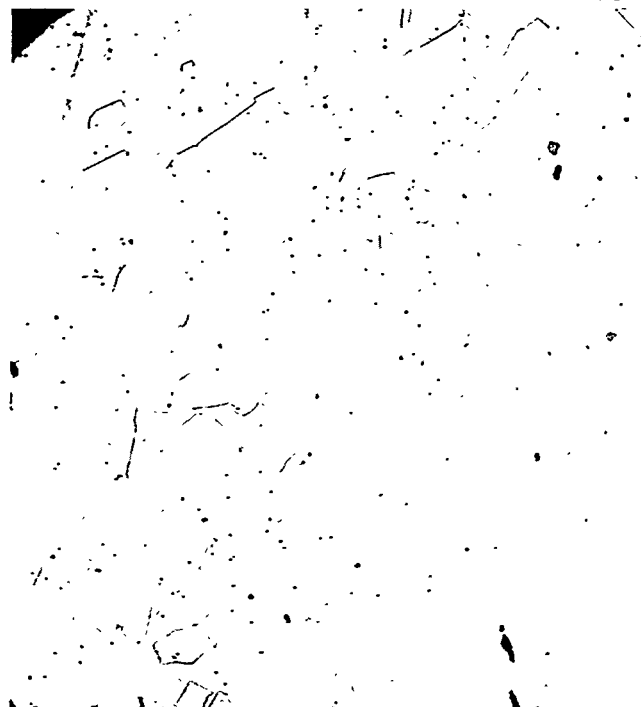
The structure in Area 1 (Fig. 4.1) is shown in Fig. 4.2b. The grains appear equiaxed with no evidence of plastic strain in this area. The structure in Area 2 (Fig. 4.1), seen in Fig. 4.2c, on the other hand shows definite grain distortion and numerous fine mechanical twins. As one moves away from the immediate fracture area (Fig. 4.2d), the grain distortion is no longer evident, although mechanical twinning is still quite pronounced.

Fig. 4.2b. Area next to fracture; area 1 (Fig. 4.1.).
No evidence of plastic deformation.

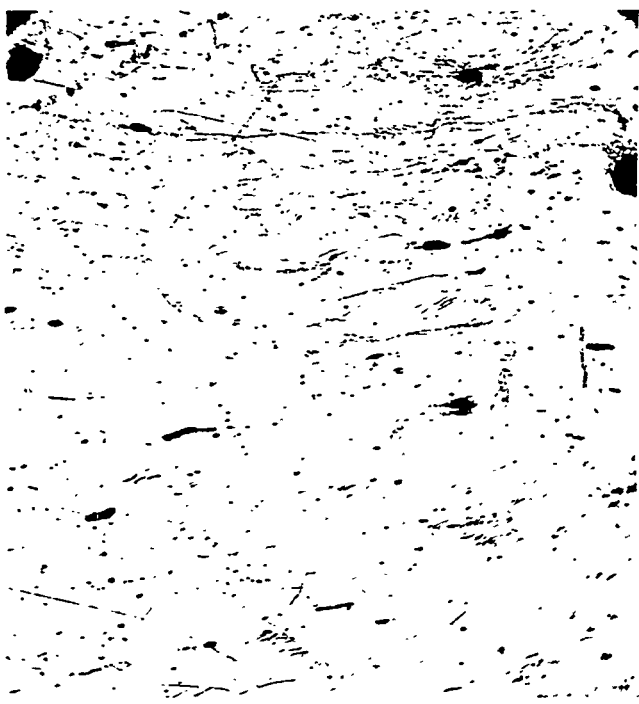
Fig. 4.2c. Area next to fracture; area 2 (Fig. 4.1).
Mechanical twinning and grain distortion
apparent.

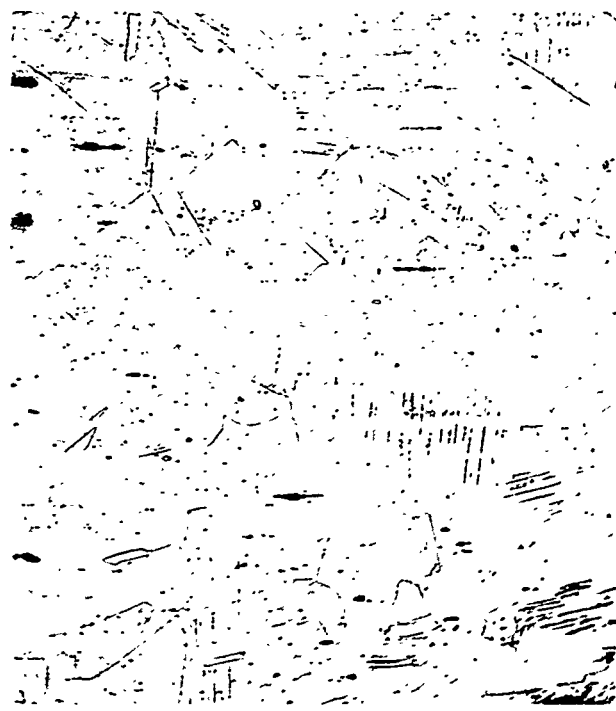
Fig. 4.2d. Slightly further away from the fracture
than area shown in Fig. 4.2c; area 2
(Fig. 4.1). Mechanical twinning present.

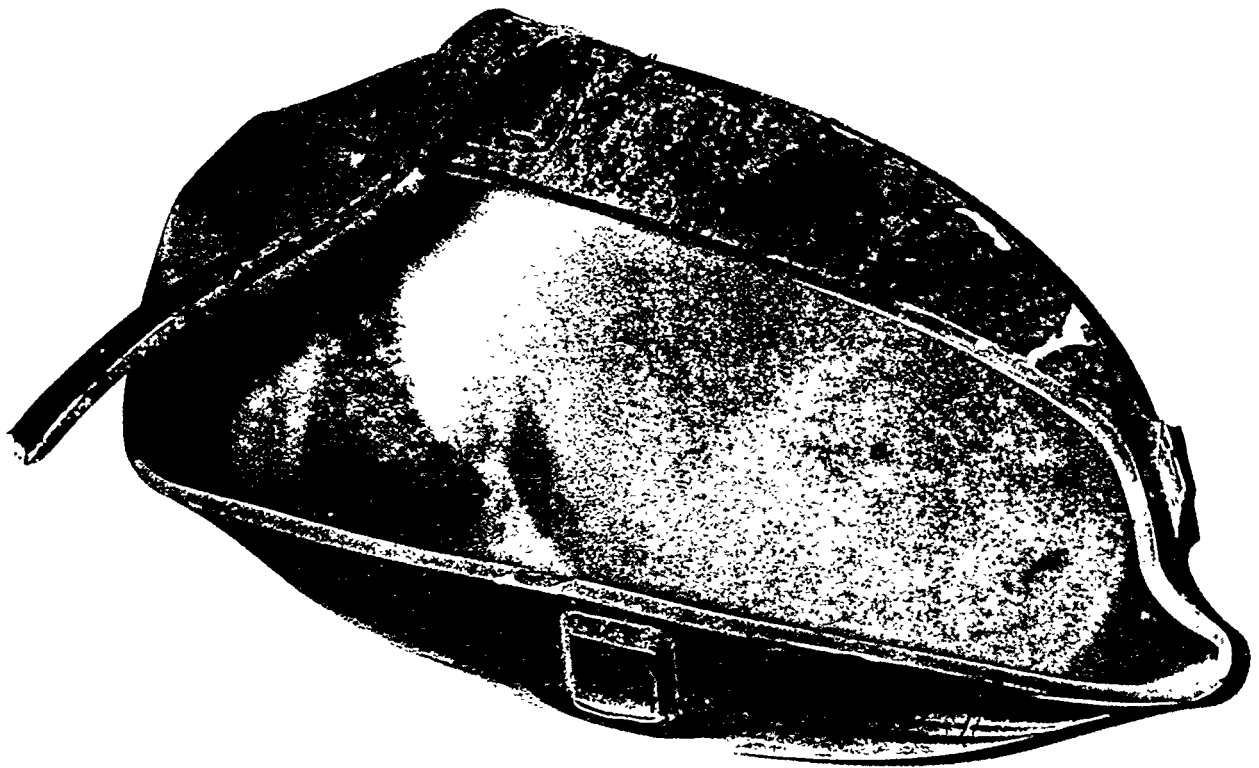
Fig. 4.3. Baffle from vapor separator P-2.

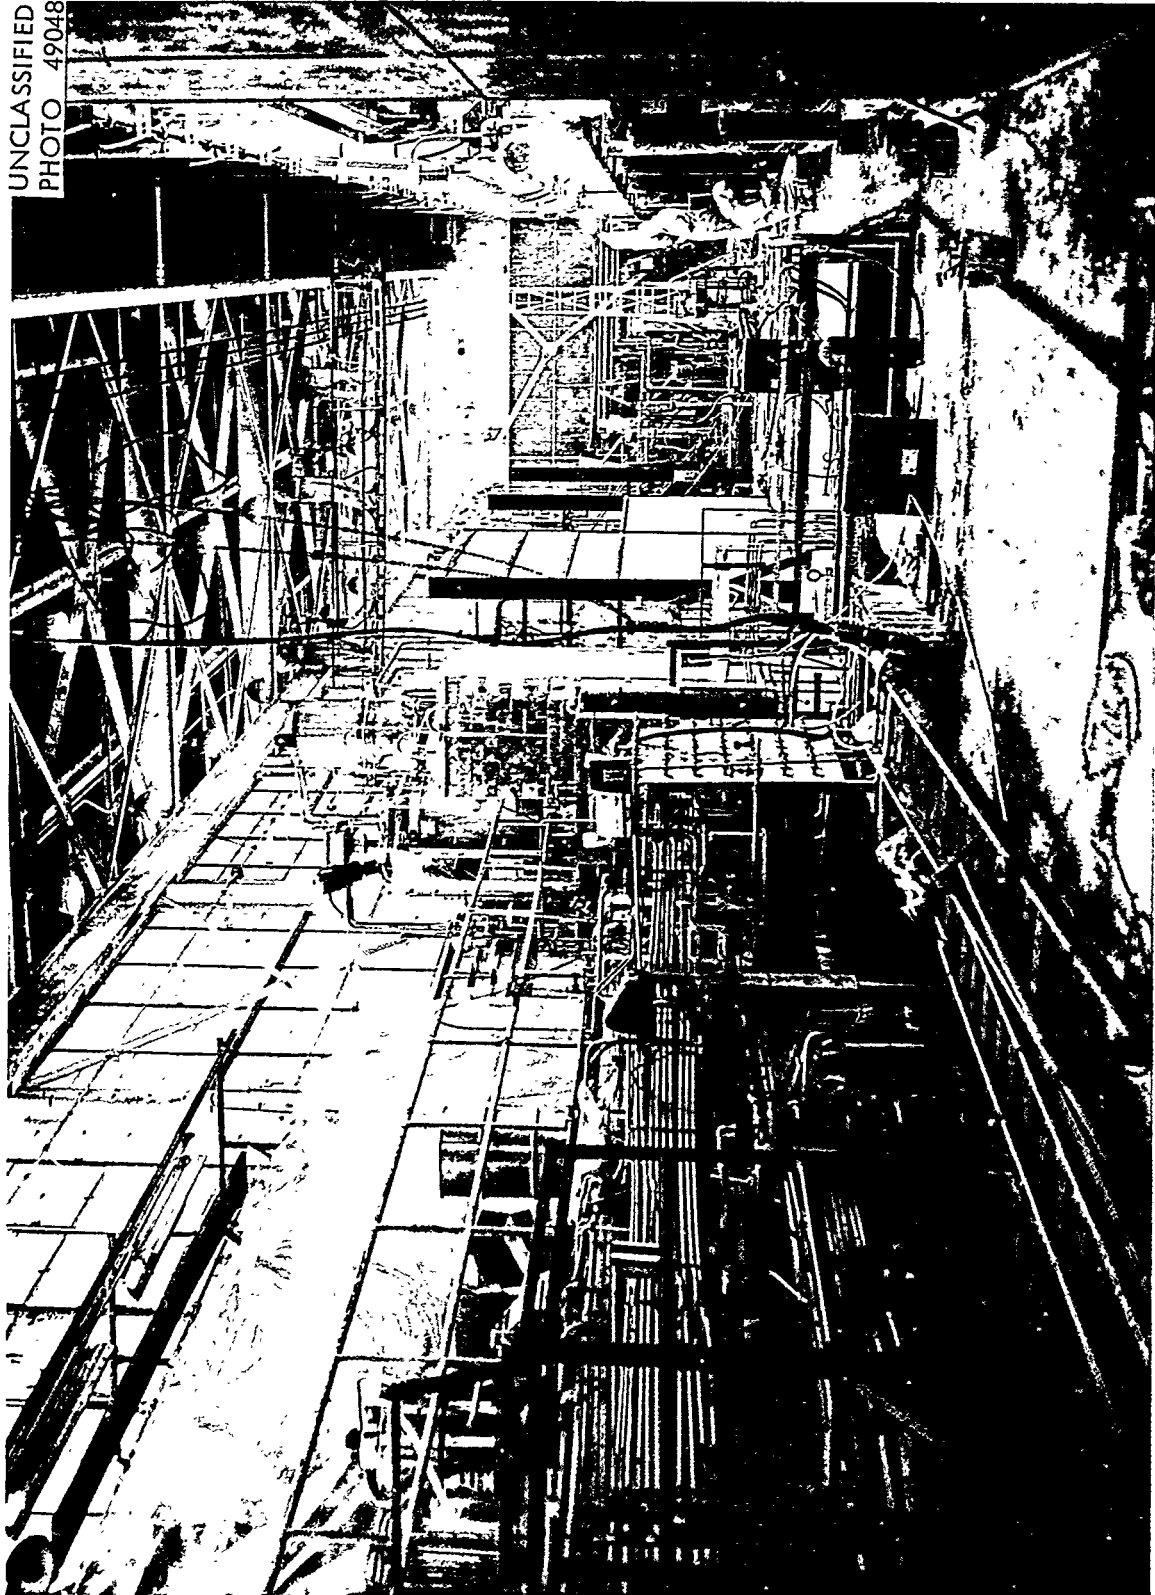
Fig. 5.1. Radiochemical Processing Pilot Plant penthouse during decontamination after explosion.

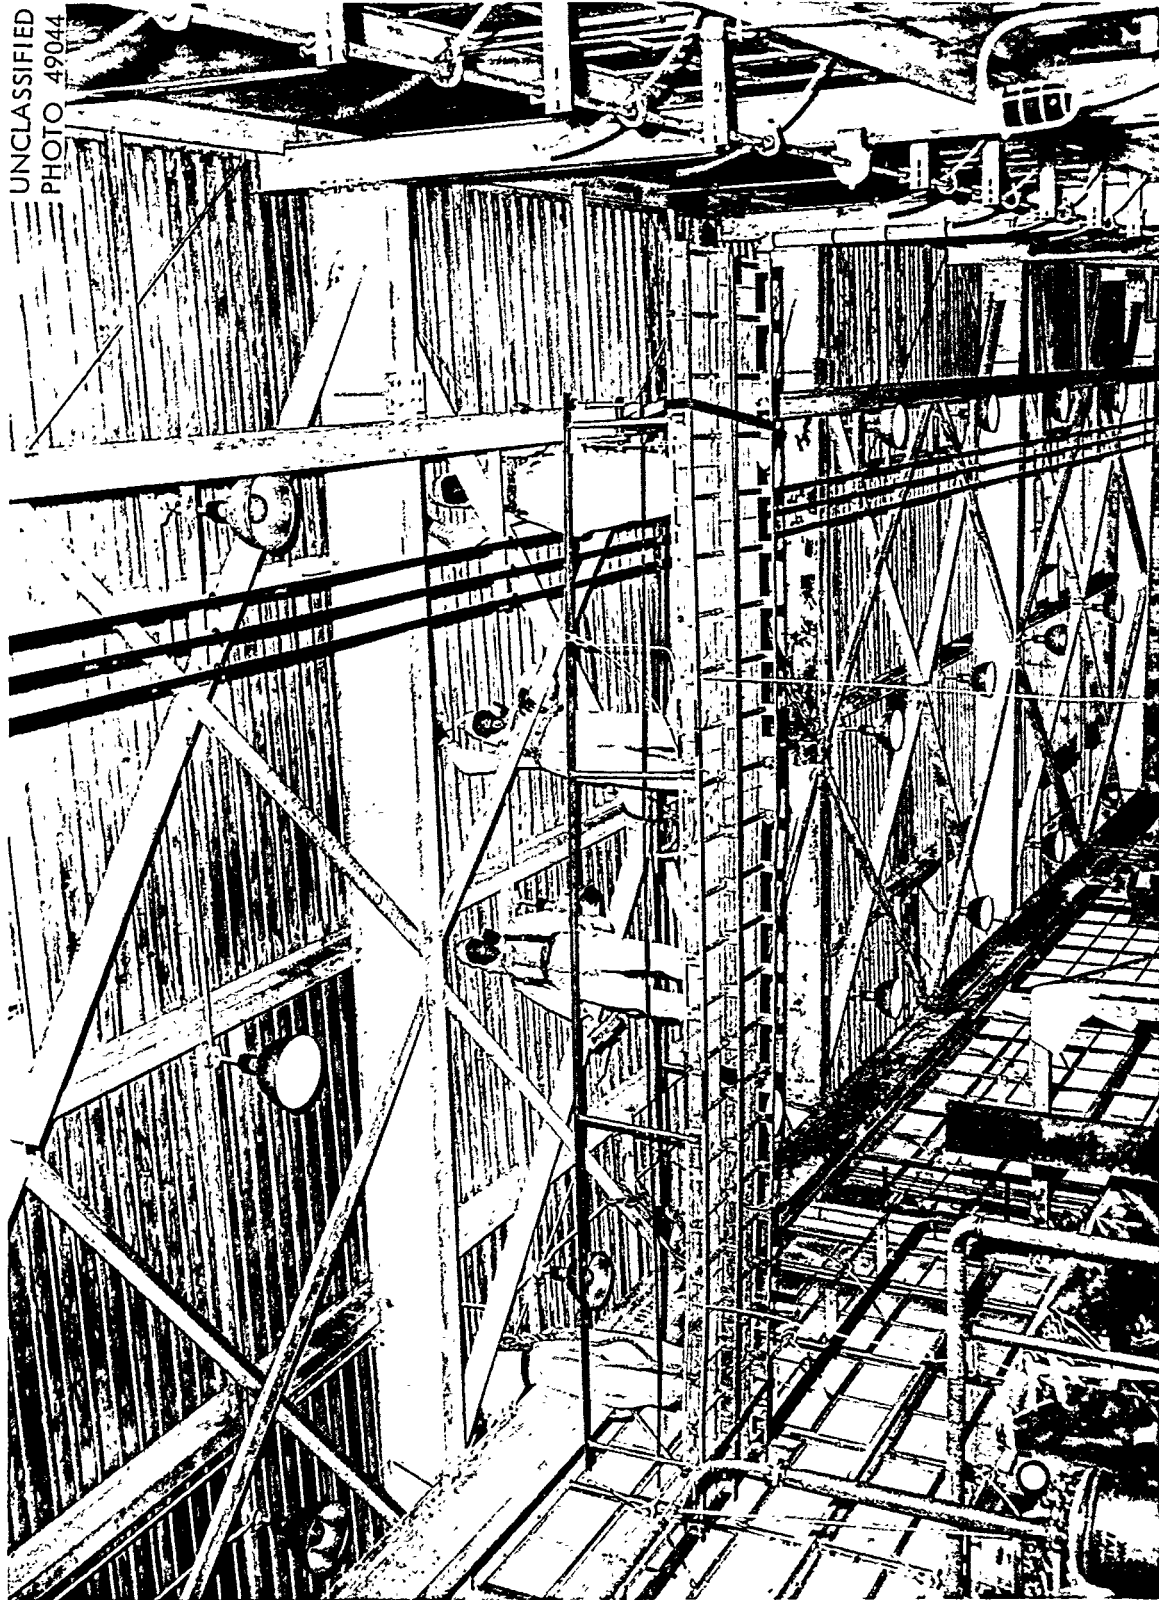
decontaminated. The penthouse, especially the ceiling (Fig. 5.2) was the most difficult part of the building to decontaminate, and about half of the total building cleanup effort was expended there. Alpha activity had become fixed in the paint, probably during previous programs. After a number of decontamination methods were tried (scrubbing with detergent and water, scraping off loose paint, applying a strippable plastic coating and then stripping it off, and sanding either by hand or with mechanical sanders), the method selected was to remove almost all the paint with paint remover and scrapers and then scrub with detergent and water. Some I beams on the crane supports were removed to a remote decontamination area where they were decontaminated by grinding to a polish. However, this method could not be used in the penthouse because of the danger to personnel of handling portable grinding machines while they were wearing bulky protective clothing, slippery plastic shoe covers, and vision-limiting masks and because of the tendency of grinding operations to spread the contamination by dispersing it in the air.

Fig. 5.2. Radiochemical Processing Pilot Plant penthouse ceiling during decontamination after explosion.

The concrete floor of the penthouse was unsuccessfully scrubbed with detergent and water and with dilute acid. It was necessary to remove about 1/8 in. of concrete with a rotary scarifier and then chip out "hot spots" before the contamination was decreased to the point that sealing in the remaining activity with a 2-in. layer of concrete was acceptable.

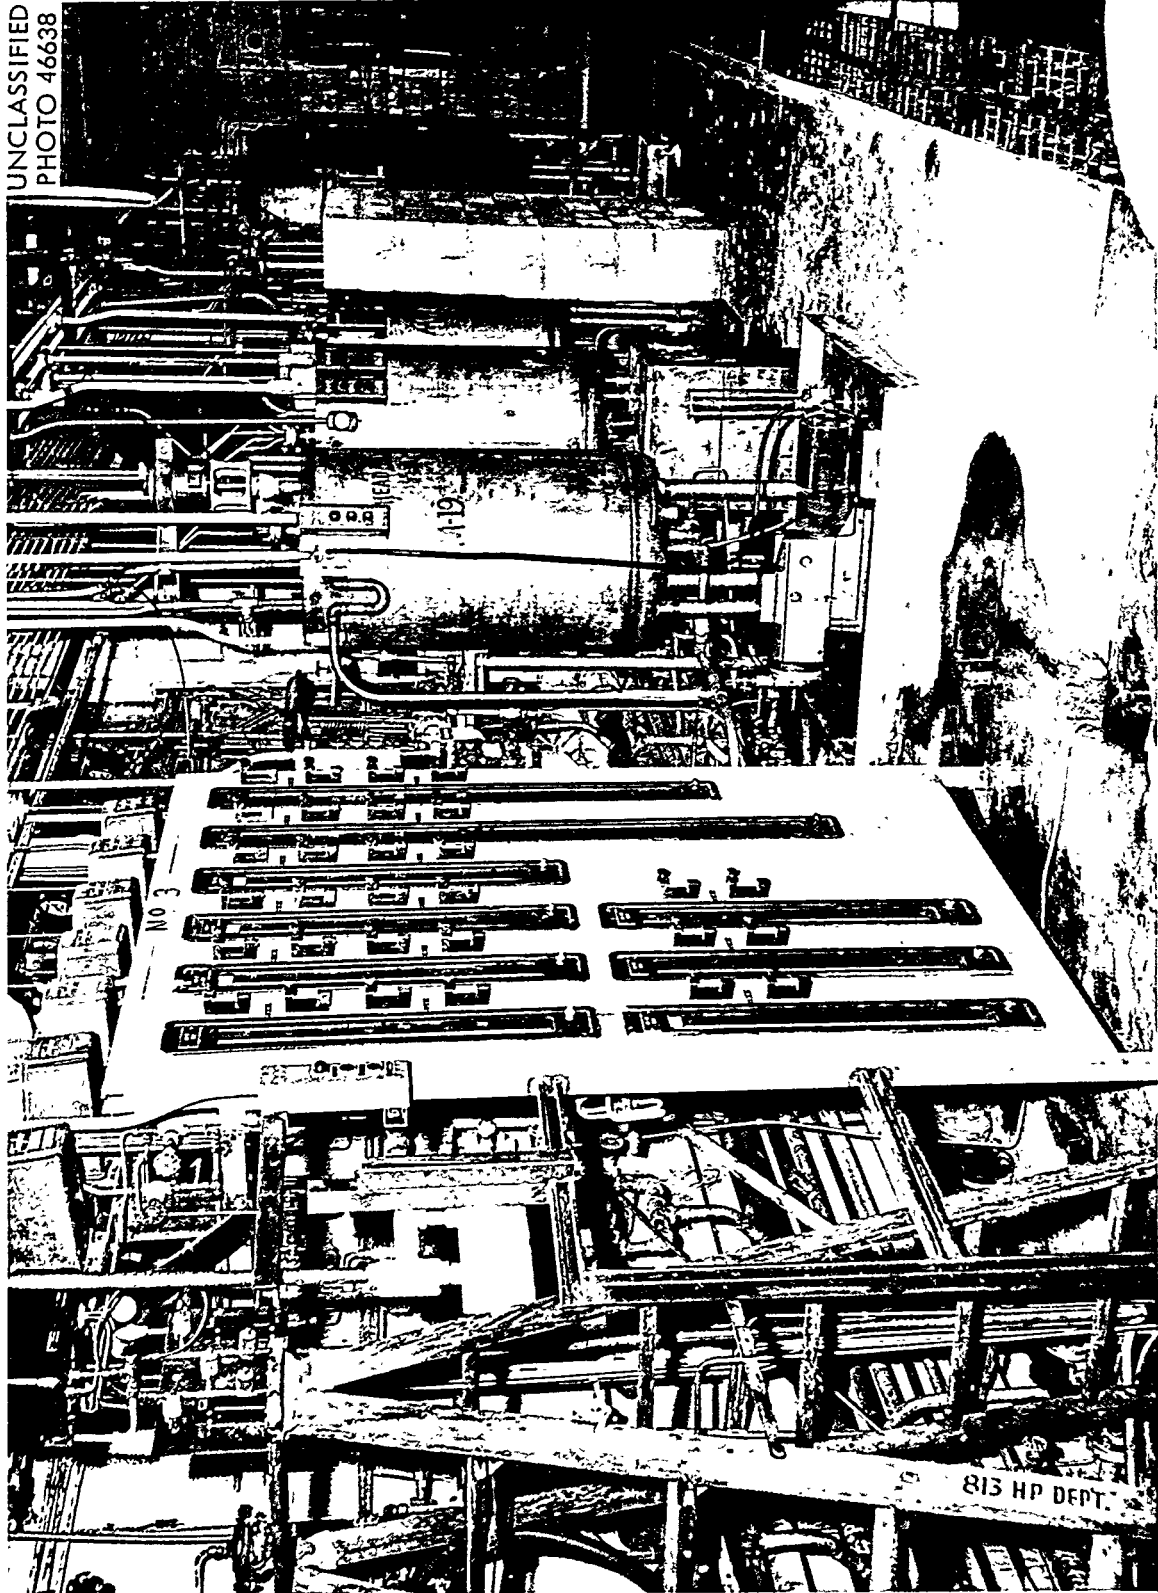
b. Cold Solution Makeup Area. This area (Fig. 5.4) presented two special problems, a concrete floor badly pitted from acid spills and heavy traffic, and mild steel pipes for plant services (air, water, and steam). After the pumps were removed, the tanks were suspended from the ceiling, the tank support legs were cut off, and the concrete floor was chipped out with jack-hammers. A new floor was poured and a stainless steel floor liner was installed before the tanks and pumps were again in-

Fig. 5.4. Power reactor fuels processing pilot plant cold solution makeup area.

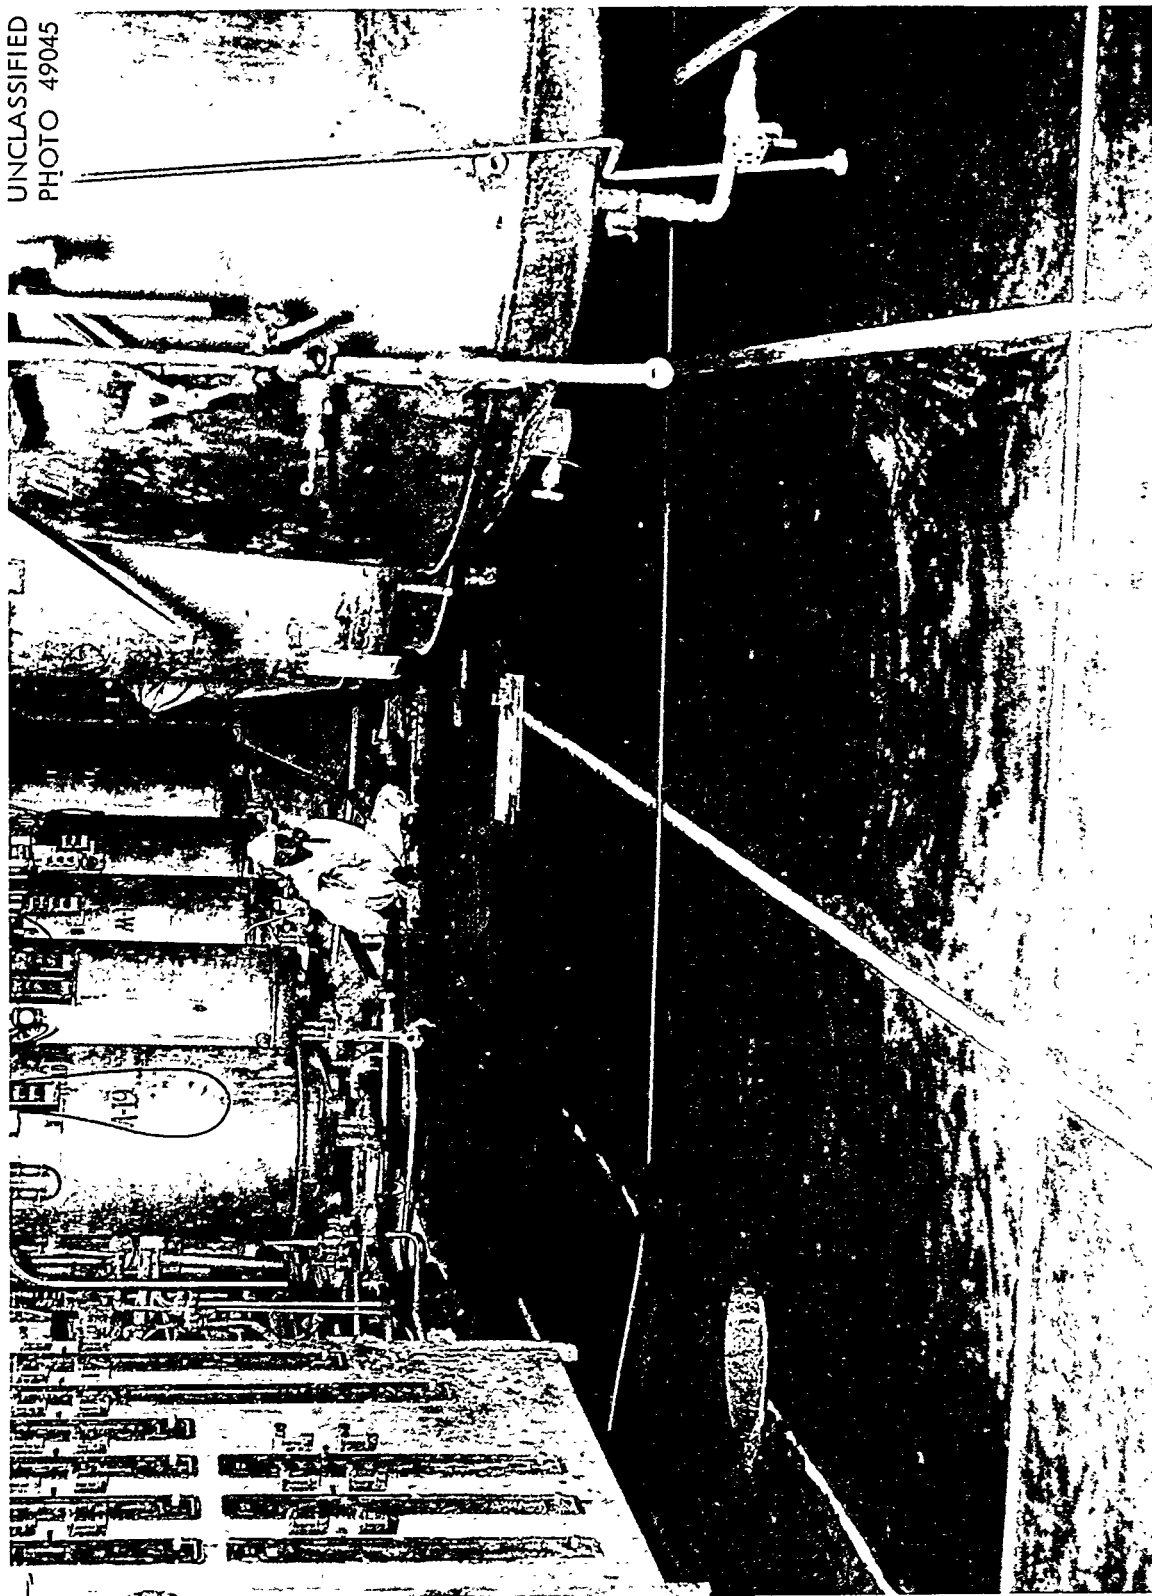
Fig. 5.5. Power reactor fuels processing pilot plant cold solution makeup area during decontamination after explosion.

stalled. Figure 5.5 shows this area during installation of the new floor.
